**National Highway
Traffic Safety
Administration**

Case Vehicle (A): 1998 Ford
Type: Escort, 2-door coupe
Driver: 28-year-old female
CDC: 11-LFEW-3

Vehicle (B): 1989 Plymouth
Type: Reliant, 4-door sedan
Driver: 84-year-old male
CDC: 99-0000-0

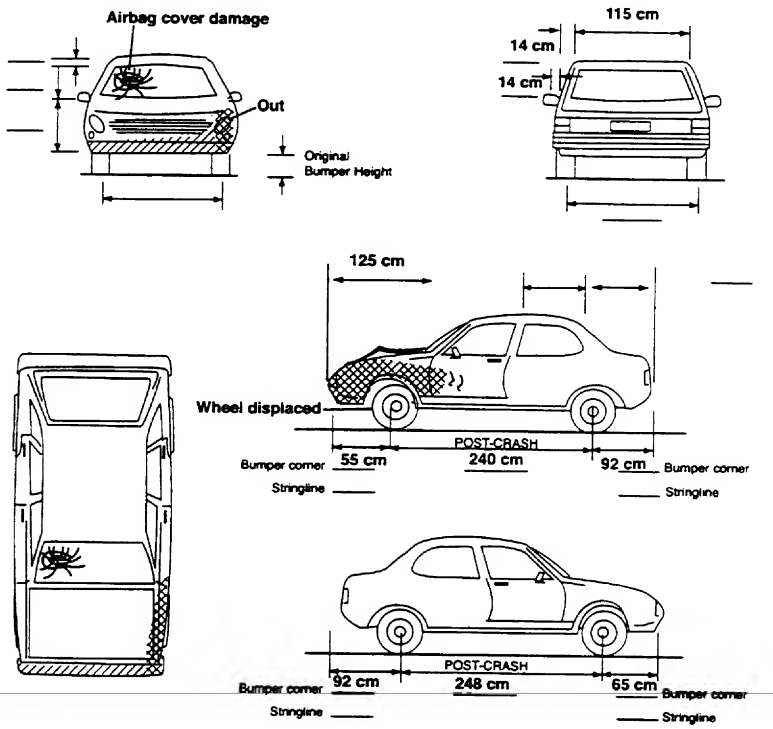
Specific Impact No.	Location of Direct Damage	Location of Field L
1	Begins +203cm from ctr of rear axle	Begins +201 from rear axle

Specific Impact Number	Plane of Impact C-Measur.	Direct Damage Length (DDL)	Direct Damage Max Crush	Field L	C_1	C_2	C_3	C_4	C_5	C_6	±D
1	4	160 @ bumper level		116	5	8	15	19	26	37	+135
–	–	stringline adj			-5	-5	-5	-5	-5	-5	
					0	3	10	14	26	32	
–		Body taper			-0	-0	-0	-0	-0	-5	
1	4	160	032	116	000	003	010	014	026	032	+135
13	14	15 16 17	18 19 20	21 22 23	24 25 26	27 28 29	30 31 32	33 34 35	36 37 38	39 40 41	42 43 44 45
2

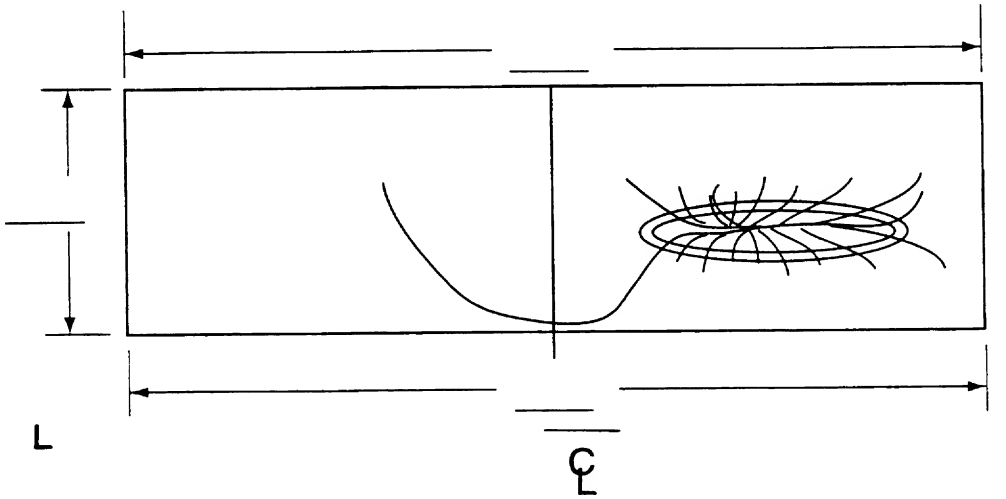
Airbag cover door damage

(Slides 10, 11, 12, 13, 14, 15) This vehicle was equipped with both steering-wheel and passenger frontal-impact airbags, which deployed during the left-side impact. (Slides 16, 17, 18, 19, 20, 21) No damage was noted to the airbag skins or module doors/flaps. (Slide 22) The steering-wheel rim was not deformed, and the steering-wheel column was not rotated. (Slides 23, 24, 25, 26, 27, 28, 29) The windshield was cracked due to contact by the passenger frontal-impact airbag cover door. No intrusions were noted.

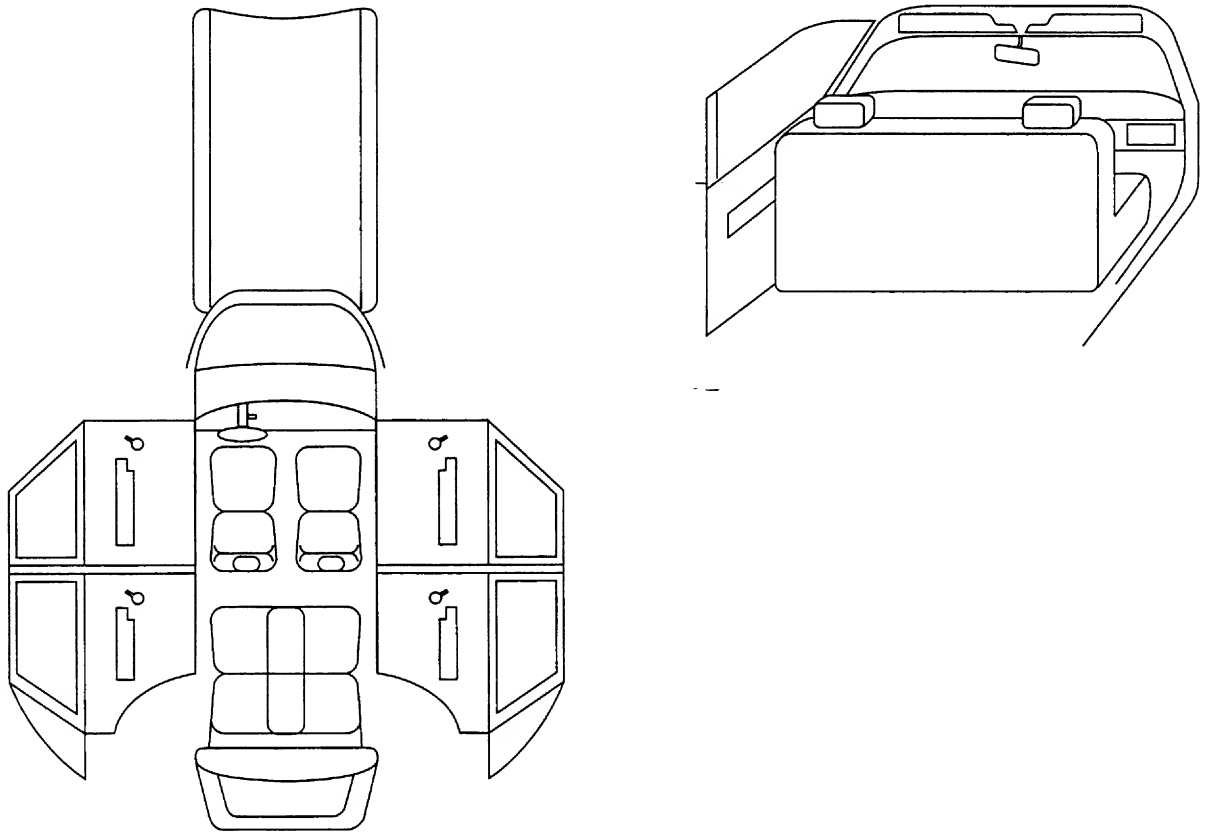
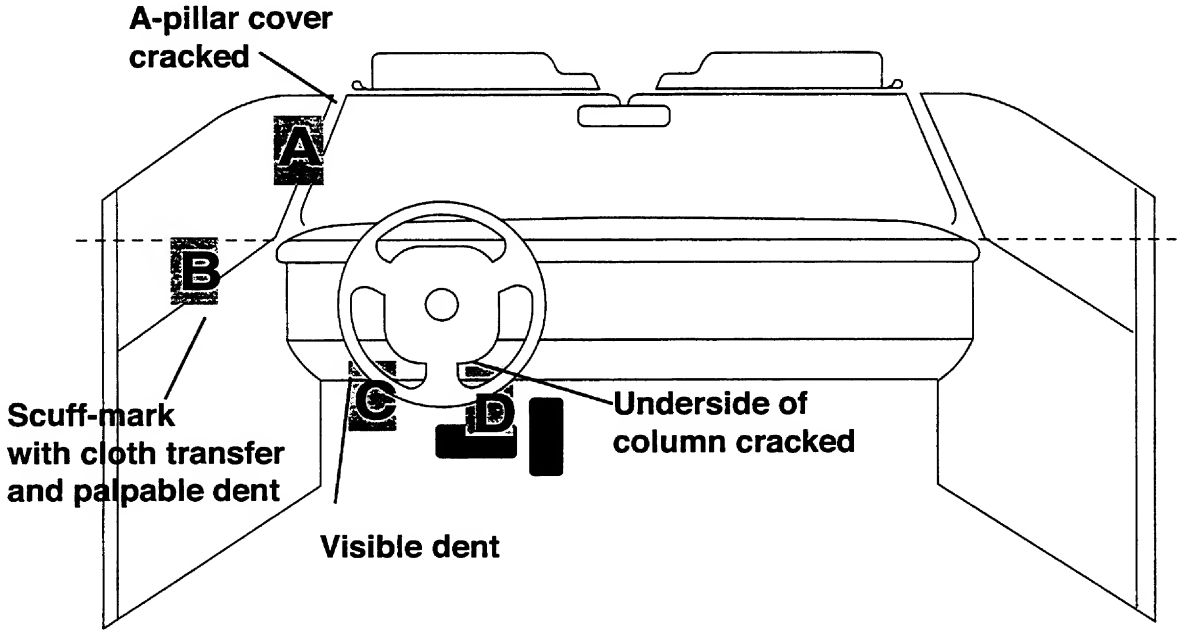
VEHICLE OCCUPANT CONTACT DIAGRAM

Contact	Interior Component Contacted	Occupant No. if Known	Body Region if Known	Supporting Physical Evidence	Confidence Level of Contact Point
A	Upper A-pillar	1	Head	Cracked	1
B	Door	1	Shoulder	Scuff mark	1
C	Knee bolster	1	Knee	Visible dent	1
D	Underside of steering column	1	Knee	cracked	
E					
F					
G					
H
